TO: ALL TOYOTA DEALER PRINCIPALS,
SERVICE MANAGERS, PARTS MANAGERS

SUBJECT: SPECIAL SERVICE CAMPAIGN (SSC) – 50J PHASE 1
(FRONT SUSPENSION LOWER BALL JOINT)

**FRONT SUSPENSION LOWER BALL JOINT REPLACEMENT
FOR THE FOLLOWING VEHICLES**

(Updated on January 18, 2007)

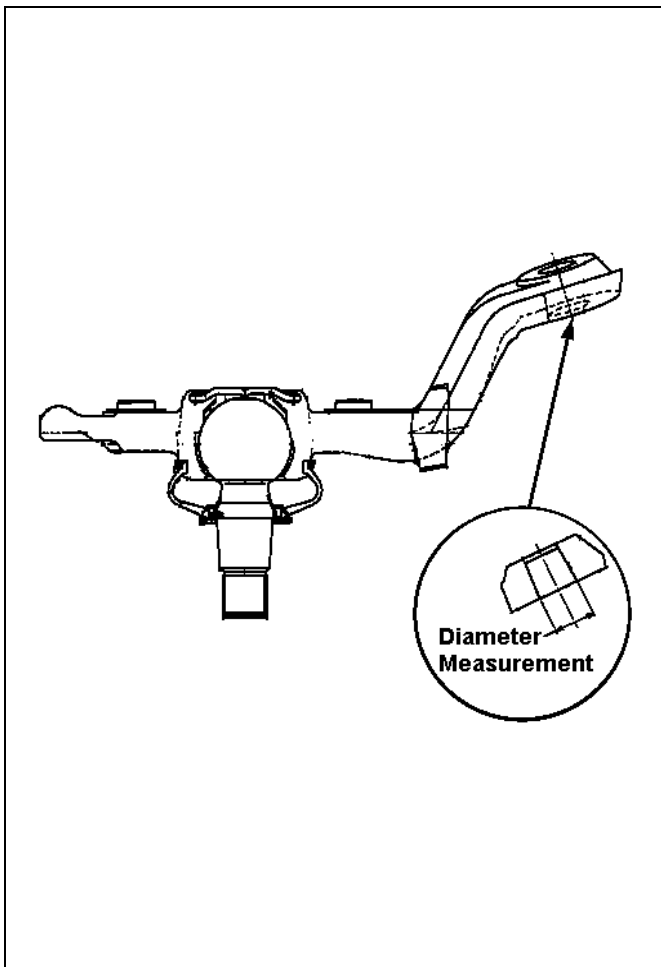
1. INSPECT THE DIAMETER OF THE TIE ROD BOLT HOLE

- (a) Disconnect the tie rod from the lower ball joint following the procedures outlined in the **Suspension And Axle: Front Lower Ball Joint** section of the appropriate vehicle Repair Manual.
- (b) Measure the diameter of the tie rod bolt hole, as shown in the illustration.

- If the diameter is 16 mm, replace the lower ball joint using part **04005-04134**. Proceed to section **"VII. WORK PROCEDURE"**.
- If the diameter is 17 mm, replace the lower ball joint using part **04005-21134**. Proceed to section **"VII. WORK PROCEDURE"**.
- If the diameter of the tie rod bolt hole cannot be determined, the production lot number on the lower ball joint must be verified. Proceed to step **"2. LOCATE THE PRODUCTION LOT NUMBER"**.

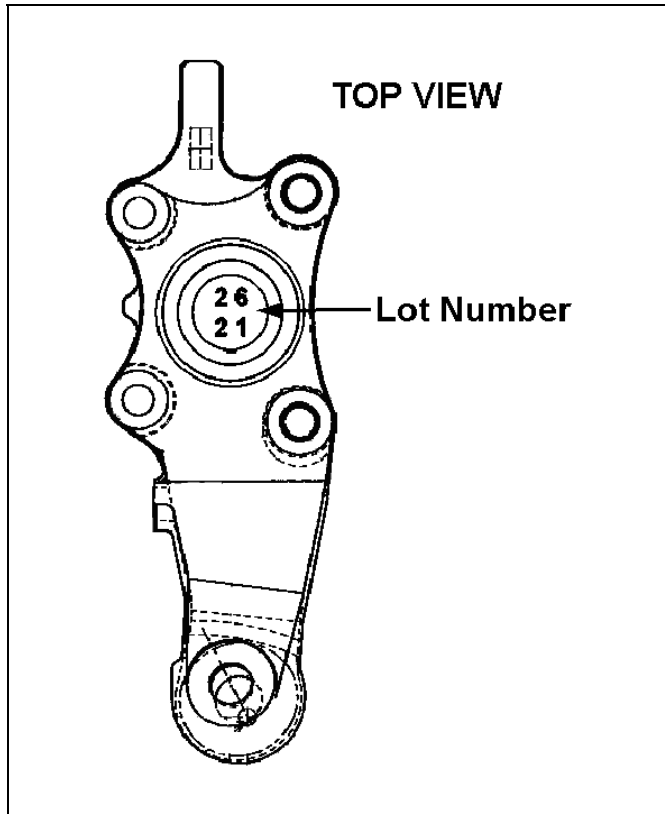
2. LOCATE THE PRODUCTION LOT NUMBER

- (a) Remove the lower ball joint following the procedures outlined in the **Suspension And Axle: Front Lower Ball Joint** section of the appropriate vehicle Repair Manual.
- (b) Locate the production lot number as shown in the illustration.

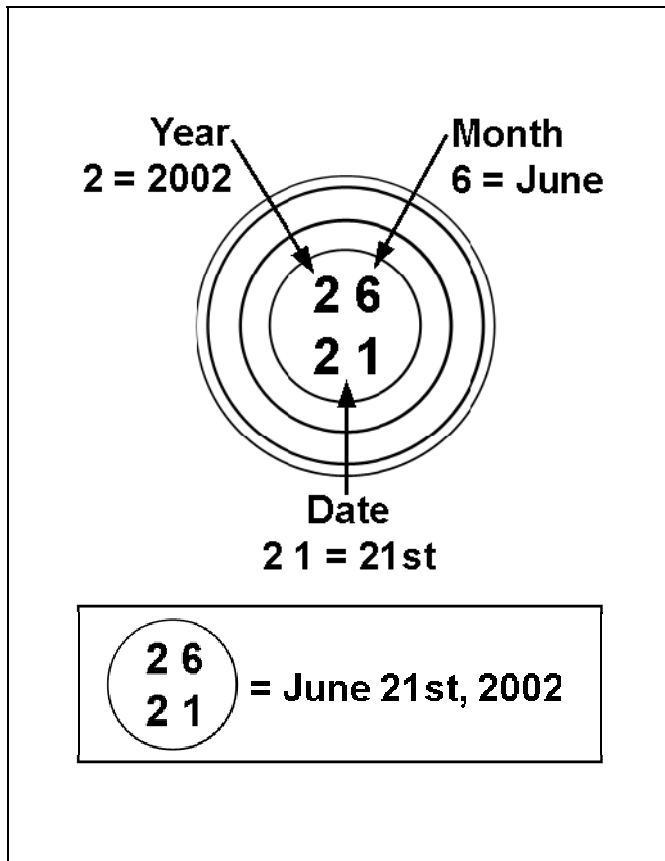
3. READING AND VERIFYING THE PRODUCTION LOT NUMBER

- (a) How to read the production lot number.
 - Upper Left Number: Year
 - Upper Right Number: Month
 - Bottom Numbers: Date
- (b) If the production lot number is...
 - **2620 (June 20th, 2002) or earlier**, replace the lower ball joint using part **04005-04134**. Proceed to section **“VII. WORK PROCEDURE”**.
 - **2622 (June 22nd, 2002) or later**, replace the lower ball joint using part **04005-21134**. Proceed to section **“VII. WORK PROCEDURE”**.

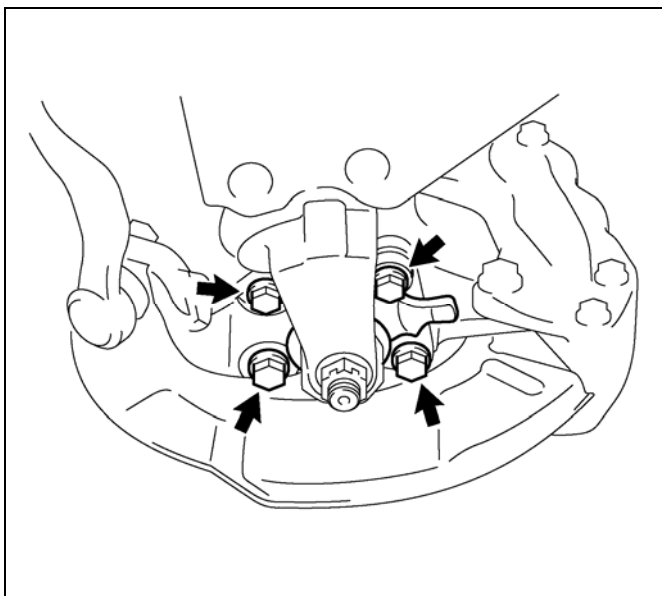
1. INSPECT THE SIZE OF THE BOLT HEADS FOR THE LOWER BALL JOINTS

*All 2003 MY Tundra vehicles should have 14mm bolt heads.

- (a) Measure the lower ball joint bolt heads.
 - If the sizes of the bolt heads are 17 mm, lower ball joint replacement **must be performed under SSC 70B.**
 - If the sizes of the bolt heads are 14 mm, replace the lower ball joints using part **04005-21134**. Proceed to section “VII. WORK PROCEDURE”.
