## Technical Service BULLETIN

# EXCESSIVE SULFUR DIOXIDE ODOR

'03 – '04 4Runner (2UZ-FE)

ENGINE  
EG020-04

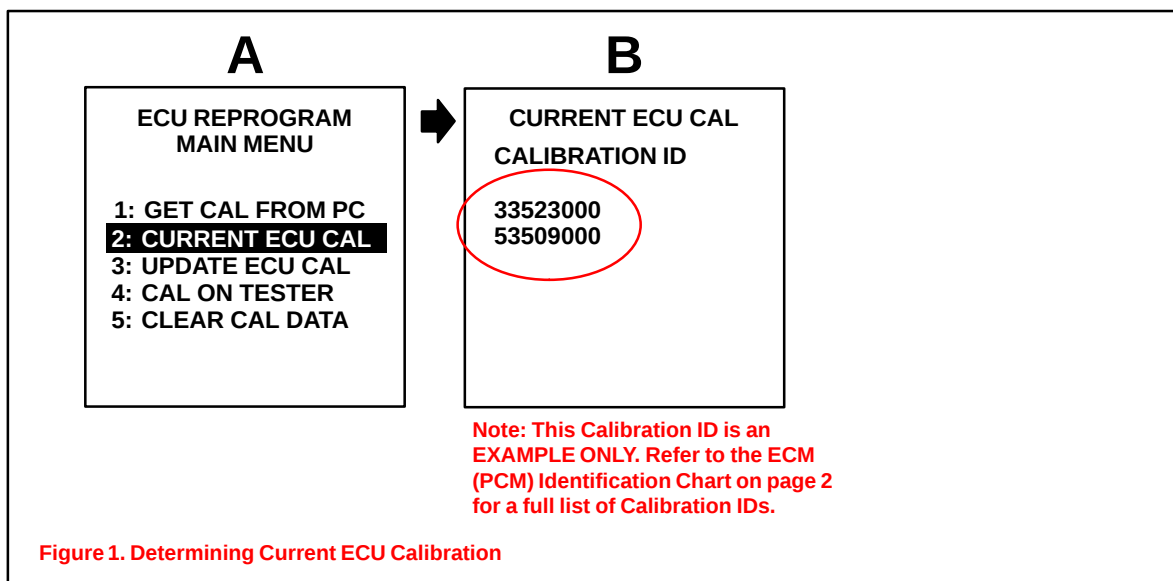
1. Check for the Authorized Modification Label affixed to the vehicle in the location shown in Figure 2 on page 4. If there is no label present, proceed to step 2.
2. Connect the Diagnostic Tester to the vehicle and select “CURRENT ECU CAL” from the “ECU REPROGRAM MAIN MENU.” To determine the vehicle’s current ECM calibration, see Figure 1 shown below.

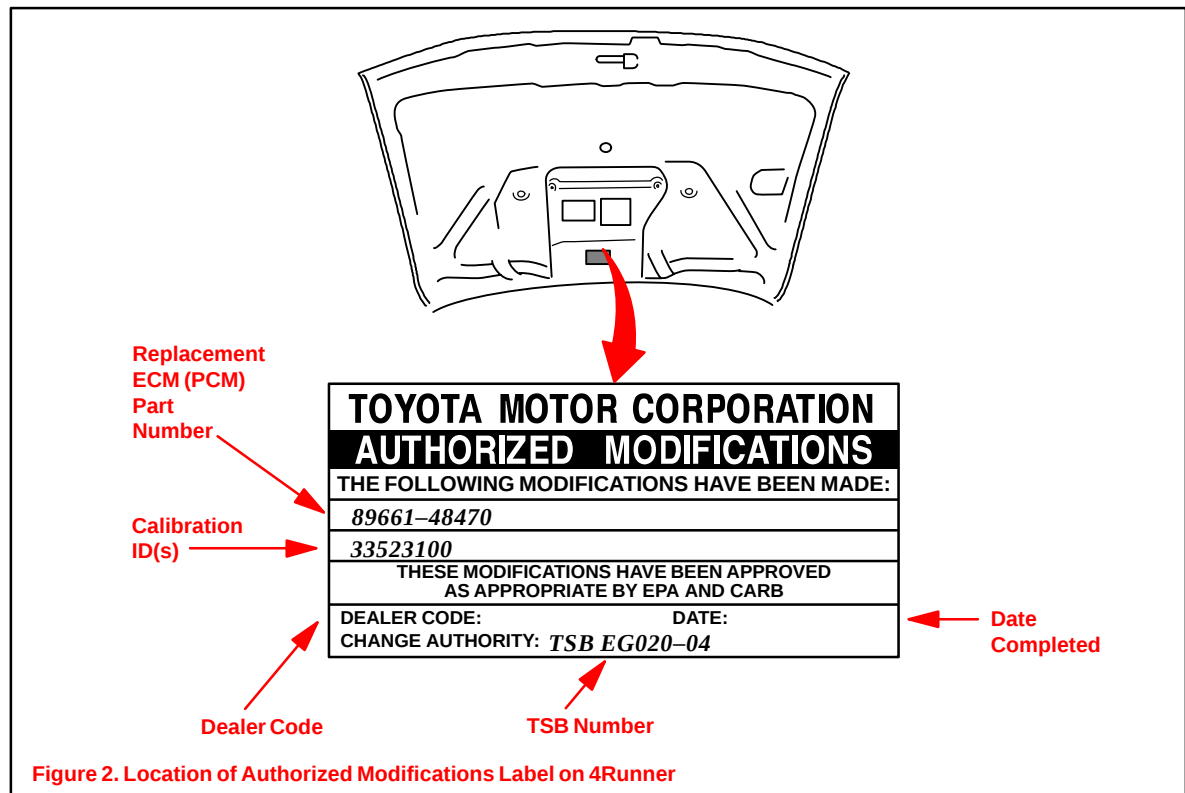
6. Start the engine and warm up the vehicle to normal operating temperatures before test-driving.
7. Test drive the vehicle to confirm proper operation and to readjust the ECM (PCM) "Learned Values."
  - Drive the vehicle using light to moderate acceleration in mostly stop and go type driving.
  - Allow the vehicle to shift fully through all gears and at various shifter positions (D, 4, 3, 2, 1).
8. Enter the following information on the Authorized Modification Label shown below in Figure 2 using a permanent marker.
  - ECM (PCM) part number.
  - New ECM (PCM) calibration number.
  - Your dealer code.
  - Reprogramming date.
  - This TSB number.
