# Upper/Lower Windshield/Rear Glass Tick Noise

The information contained in this TSB supersedes T-SB-0142-08.

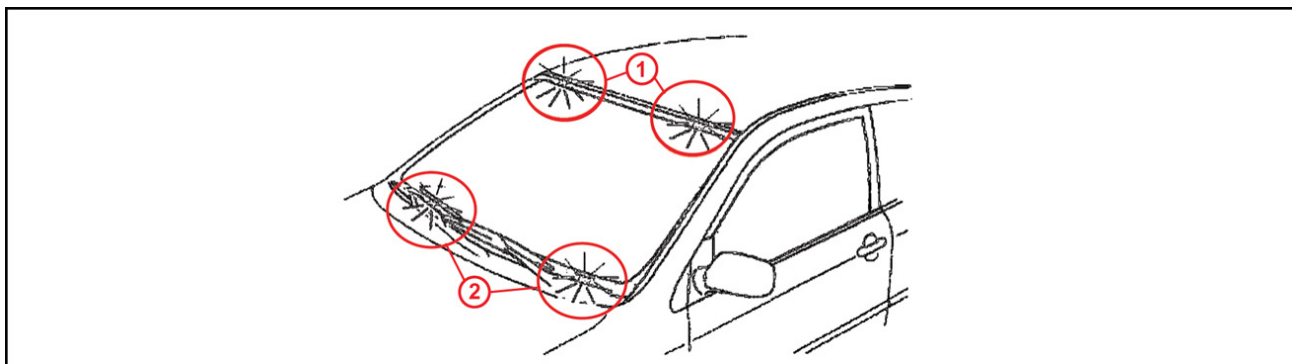
**Figure 1. Retainer and Stopper Locations**

If a creak, tick, or rattle noise is heard at the top or bottom of the windshield, or at the top of the rear glass, the source of the noise may be the two stoppers bonded to the top of the windshield/rear glass, or the windshield retainers bonded to the lower edge of the windshield. This bulletin provides the recommended repair procedure to eliminate these types of noises from the windshield/rear glass area.

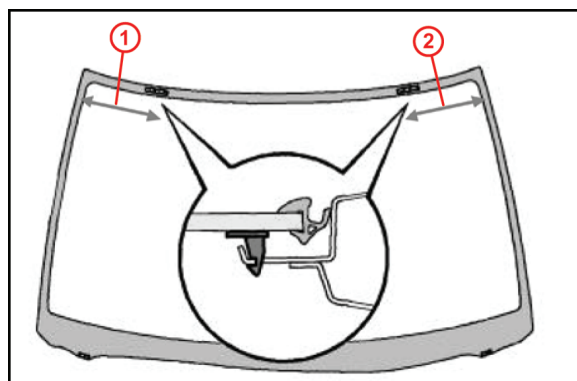
Figure 4.

The stoppers are located on the inside of the passenger compartment behind the windshield glass blackout section (near the top front edge of the metal roof opening). The stoppers are typically located 20 – 25 cm (7.9 – 9.8 in.) inboard of the top corners of the windshield glass.

1. Remove both sun visors and both A-pillar garnishes, and then carefully lower the front of the headliner to gain access to the windshield stoppers (refer to the appropriate model year Repair Manual for the proper procedure for removing and reinstalling the sun visors and headliner).

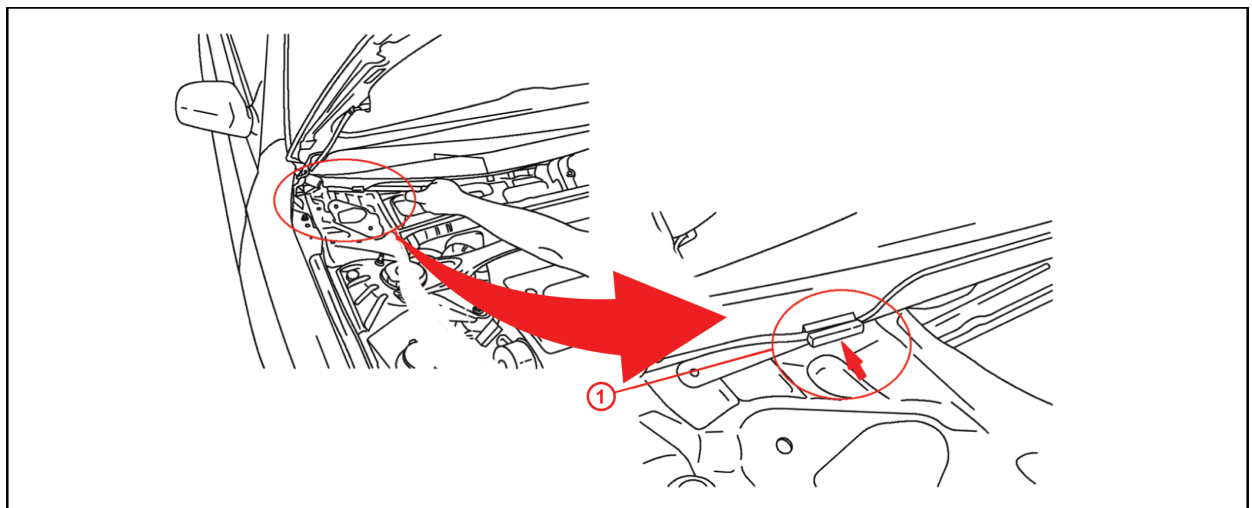
Figure 8.

The retainers are typically located 140 – 200 mm (5.5 – 7.9 in.) inboard of the lower corners of the windshield. The flat portion of the retainer is adhered to the backside of the windshield with double-sided, foam-backed tape.

2. Locate the lower windshield retainers.
