# 1st to 2nd Gear Upshift Shudder

**Service Category** Drivetrain

**Section** Automatic Transmission/Transaxle

YEAR(S)	MODEL(S)	ADDITIONAL INFORMATION
2010 – 2012	4Runner	Drive Type(s): 4WD, 2WD Engine(s): 1GR Transmission(s): 5AT VDS(s): BU5JR, ZU5JR

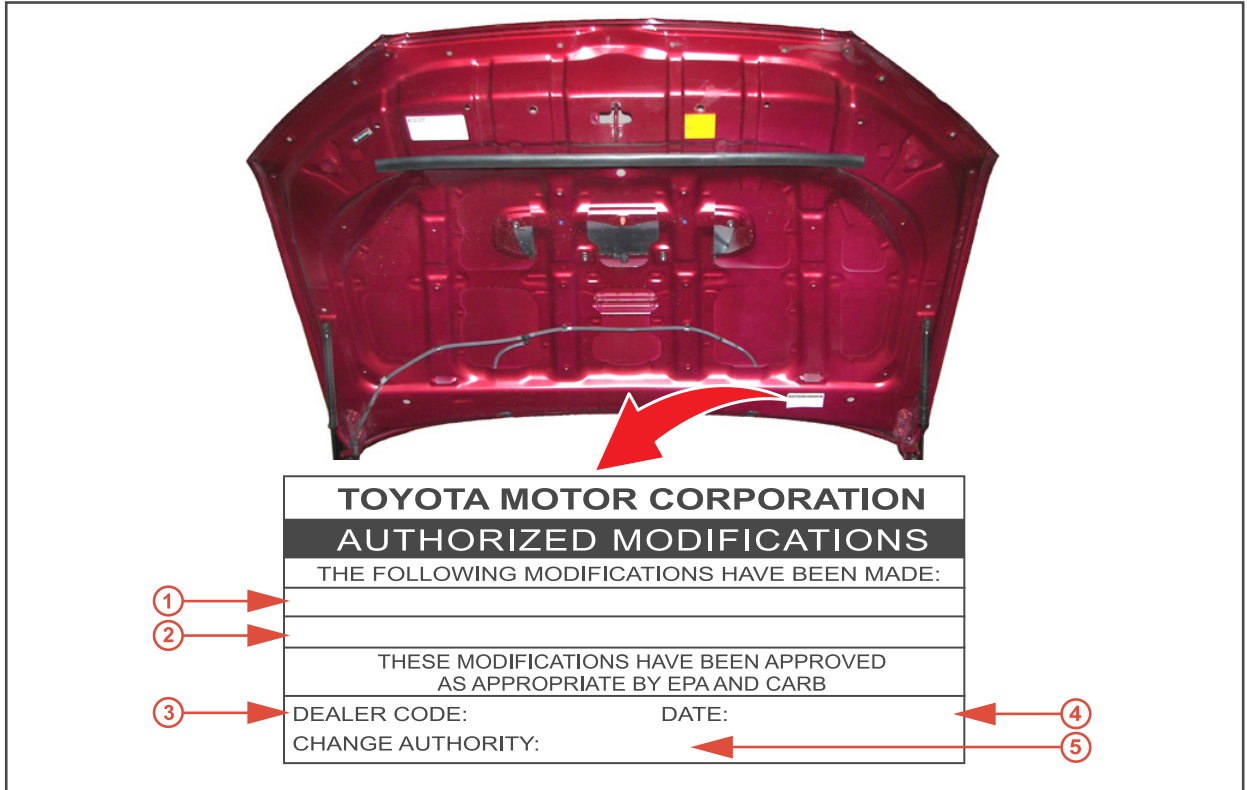
**Figure 1. Location of Authorized Modifications Label on 2010 – 2012 4Runner**

<b>1</b>	Replacement ECM (PCM) Part Number (i.e., 89661-35J81)
<b>2</b>	New Calibration ID(s) (i.e., 335B1100)
<b>3</b>	Dealer Code

<b>4</b>	Date Completed
<b>5</b>	This Bulletin Number

4. Check for the Authorized Modifications Label affixed to the vehicle in the location shown in Figure 1. Confirm if the ECM (PCM) calibration has been updated. If the calibration ID listed is NOT the latest ECM (PCM) calibration — go to step 5.

B. Affix the Authorized Modifications Label to the vehicle at the location shown in Figure 1. The Authorized Modifications Label is available through the MDC, P/N 00451-00001-LBL.
