Category Vehicle Exterior

Section Exterior Panels/Trim Market USA

| YEAR(S) | MODEL(S) | ADDITIONAL INFORMATION |
|---|---|---|
| 2014 - 2020 | 4Runner | |

# Front Bumper Cover Gap at Fender

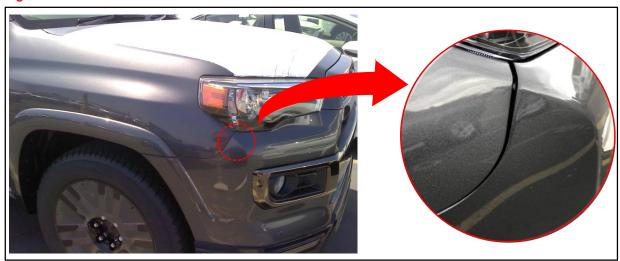
Figure 1.

- 1. Confirm the condition exists.
  - Does the vehicle exhibit a gap due to disengagement of the front bumper cover clips and the fender retainer near the headlamp assembly?
  - YES Continue to step 2.
  - NO This bulletin does NOT apply. Continue diagnosis using the applicable Repair Manual.

- 2. Remove the front bumper cover.
  Refer to TIS, applicable model and model year Repair Manual:
  - 2014 / 2015 / 2016 / 2017 / 2018 / 2019 / 2020 4Runner:
     Vehicle Exterior Exterior Panels/Trim "Exterior Panels/Trim: Front Bumper: Removal"
