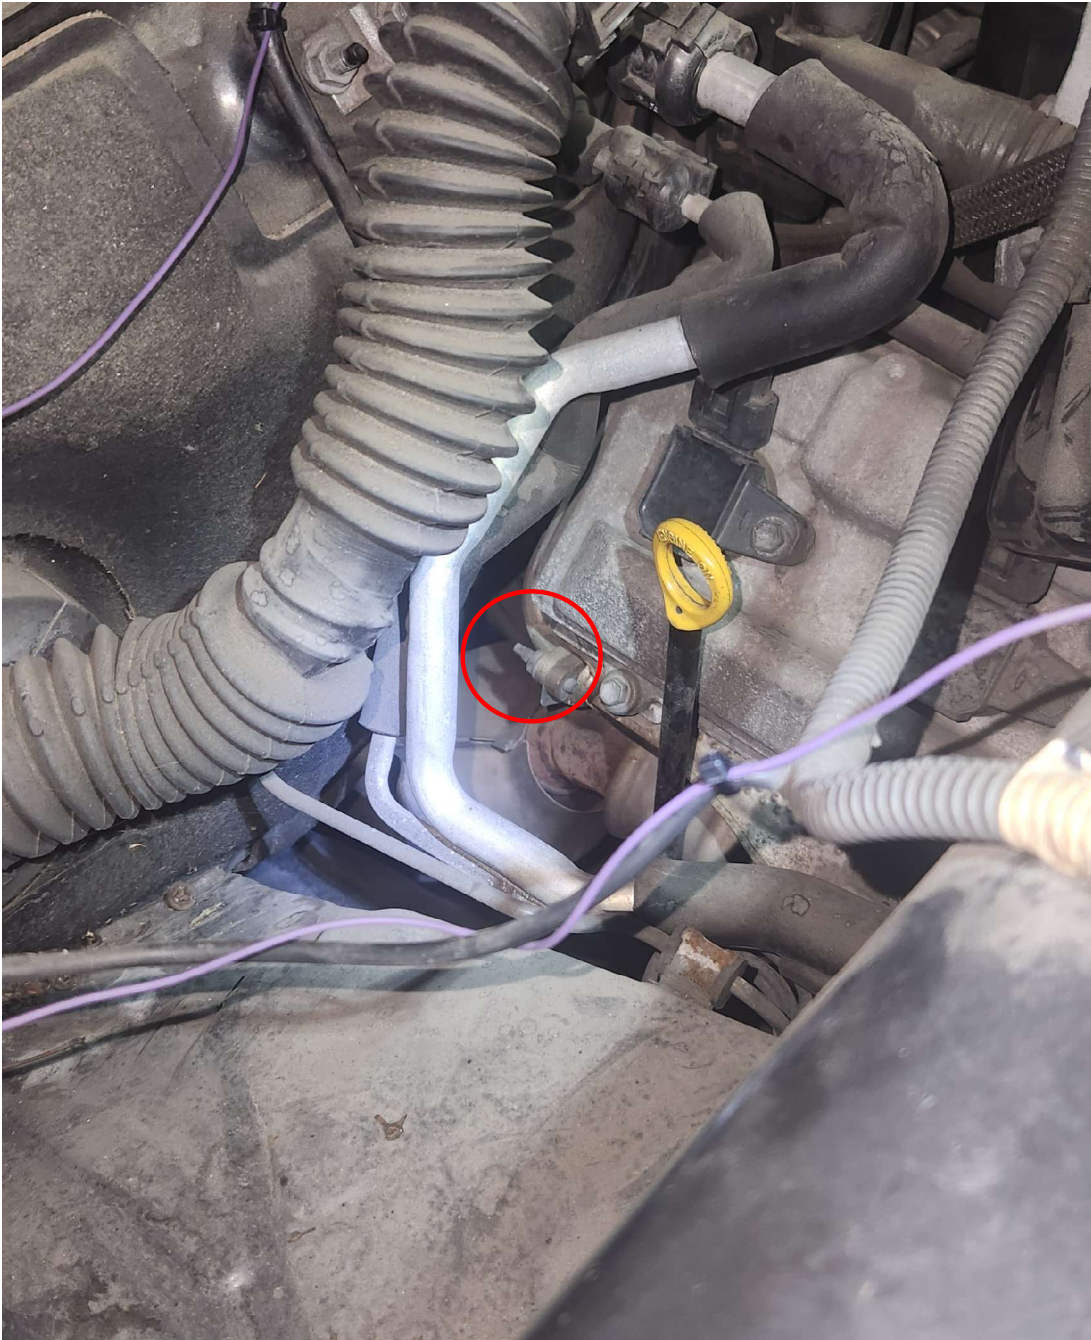
Passenger side  
of motor.

The nut holding  
the flange is  
barely visible
