**2006 Toyota 4Runner SR5**

RUST ON BACK DOOR GARNISH

Reference Number(s): BO010-07, Date of Issue: September 12, 2007

TOYOTA: '06 - '07 4Runner

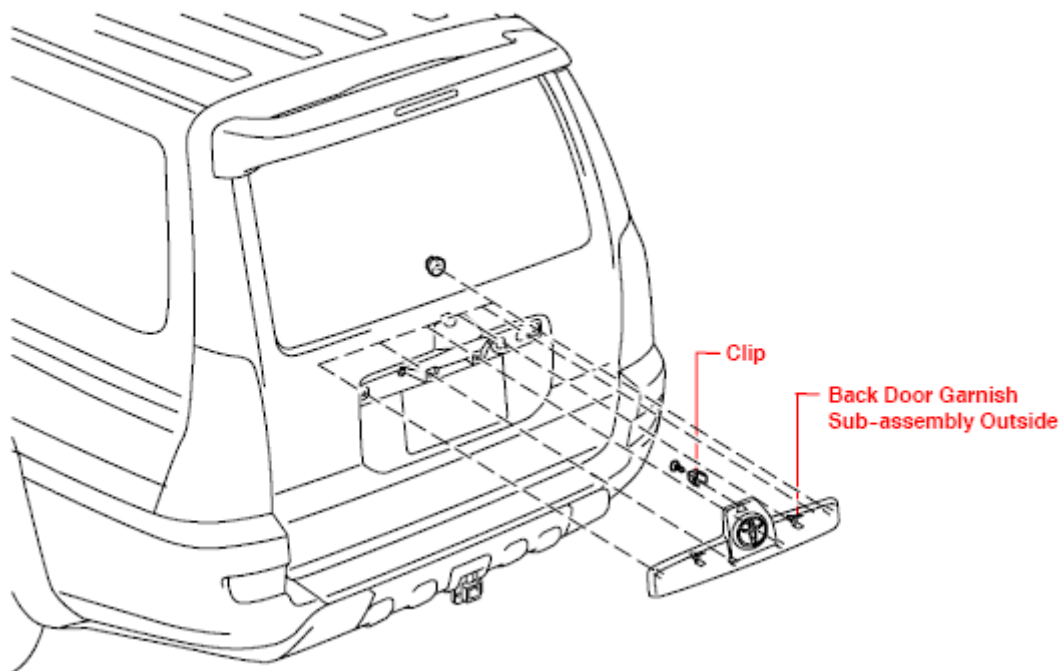
**Fig. 2: Installing Back Door Outside Garnish Sub-Assembly**  
Courtesy of TOYOTA MOTOR SALES, U.S.A., INC.

**NOTE:** Due to the varying degree of stain that can develop, some vehicles may need to be repainted (or stain will need to be cleaned).

3. Replace the back door outside garnish sub-assembly with:

- **Without the back monitor:** P/N 76801-35461
- **With the back monitor:** P/N 76801-35471
