## Technical Service BULLETIN

# DRIVER'S DOOR POWER WINDOW AND MOON ROOF INITIALIZATION

'03 - '06 4Runner

PG018-02

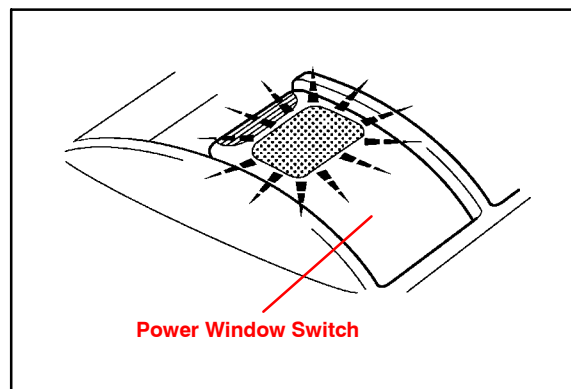
1. Push down and hold the driver's door power window switch to completely open the window.

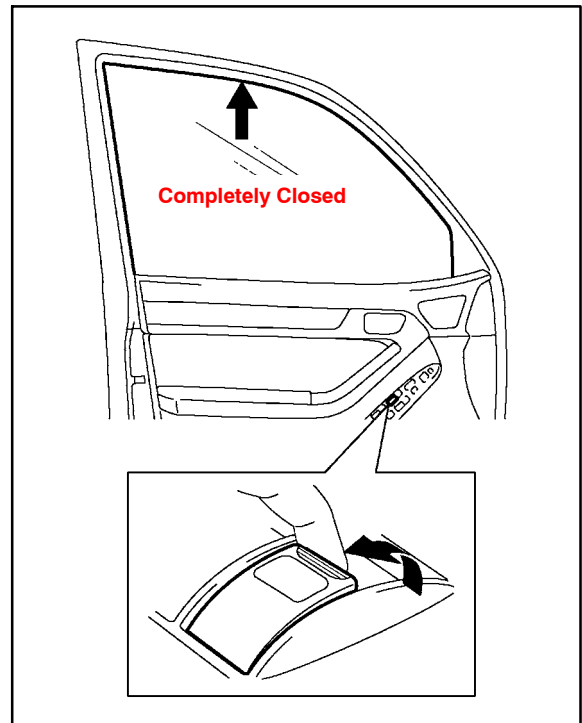
2. Pull and hold up the driver's door power window switch until the window closes. Continue holding the switch for approximately one second until the switch changes from blinking to a constant illumination.
3. Check for proper operation of the "one-touch open/close" by pushing the switch briefly to the "DOWN" and "UP" positions.

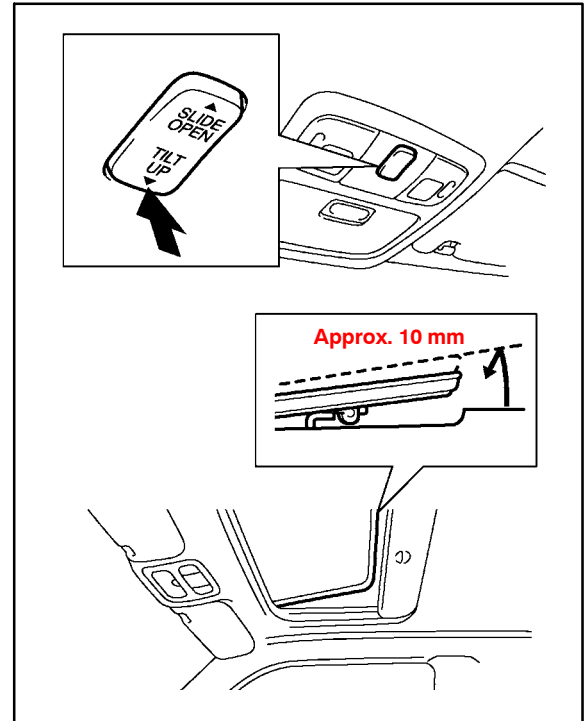
1. Push and hold the "TILT UP" side of the switch until the moon roof tilts all the way up and then tilts down slightly (approximately 10 mm [0.39 in.] at the rear).
2. Check for proper operation of the "one-touch slide open/close" and "one-touch tilt up/down" functions by pushing the switch briefly to the "SLIDE OPEN" and "TILT UP" positions.
