## Repair Manual Supplement: Vehicle Pulling to One Side

Alignment/Handling Diagnoses

**TSB SUPERSESSION NOTICE**

This bulletin contains general vehicle pulling diagnosis and repair procedures along with specific information to help correct pulling complaints.

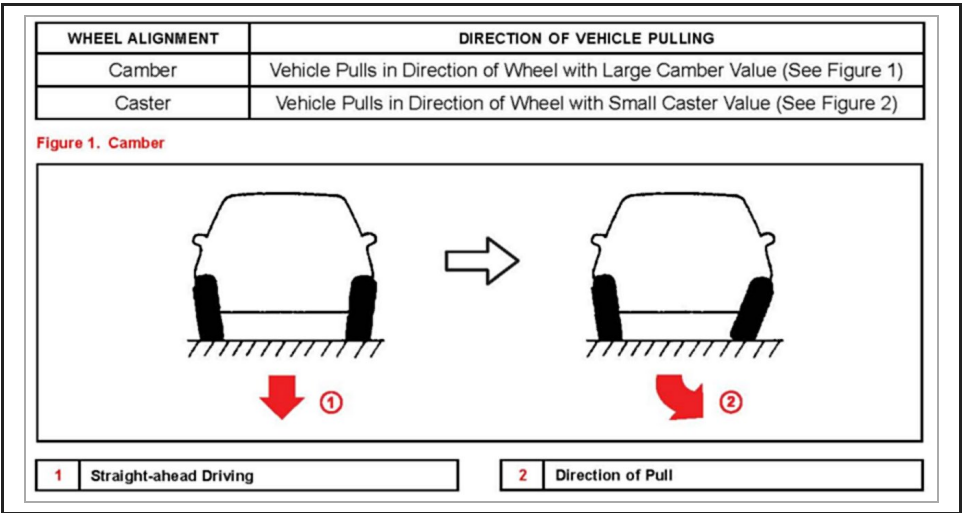
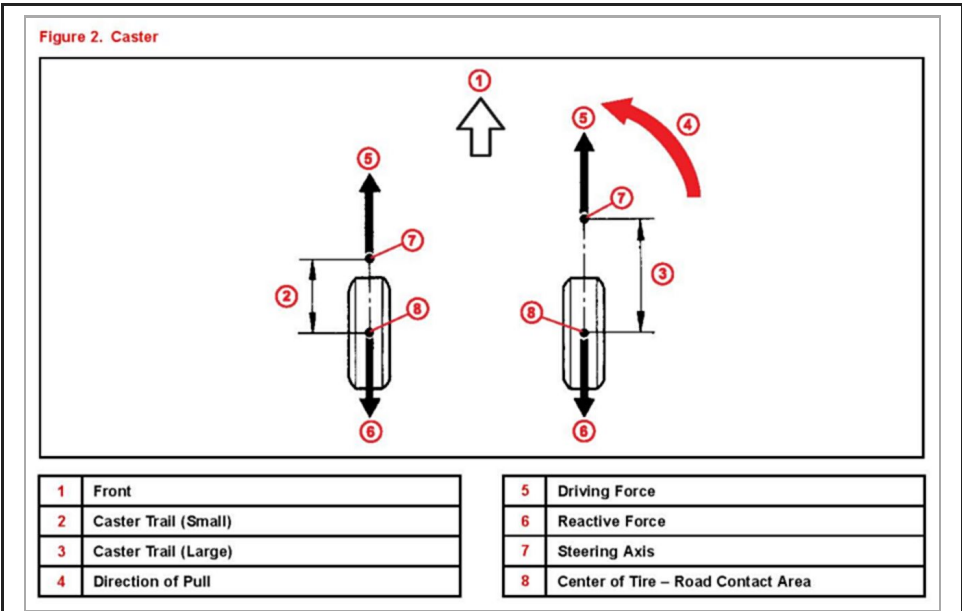
1.Relationship Between Wheel Alignment and Vehicle Pulling to One Side

When the cross camber or caster of the front wheel alignment is large it can cause vehicle pulling.

If the cross camber or caster is within the specified range (30' or less), noticeable vehicle pulling will not occur due to side-to-side differences in camber or caster.

**NOTE** On a flat road, if the cross camber or caster is 30' or less and the steering wheel is held without exerting steering effort for 109 yards (100 m) when driving at 62 mph (100 km/h), the alignment-induced drift distance is approximately 1.64 feet (0.5 m).

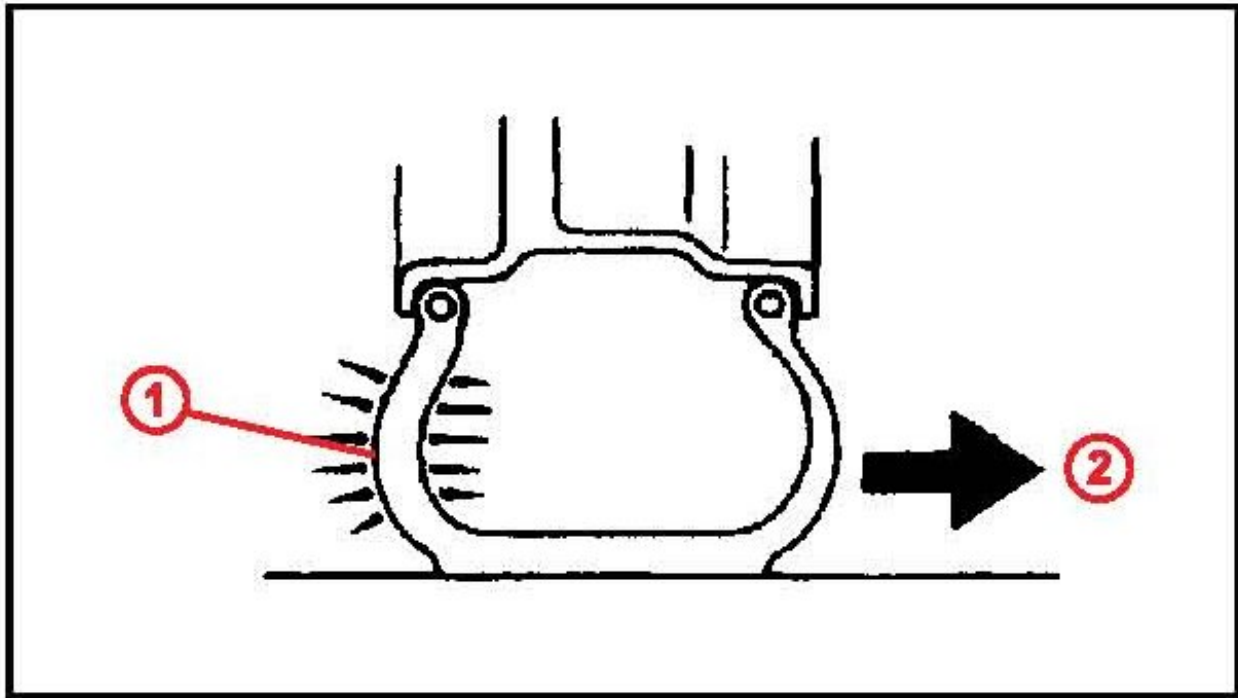
**Figure 4.**

Conicity is lateral force resulting from uneven formation of the left and right sides of the tire. The direction the lateral force is exerted depends on the hardness of the side walls and the difference in height between the left/right sides of the tire.

^ In the case of vehicle pulling caused by [tires](#), the lateral force which is exerted as a result of conicity has the greatest effect. On a flat road, if the steering wheel is held without exerting steering effort for 109 yards (100 m) when traveling at 62 mph (100 km/h), the vehicle may drift as much as 5 feet (1.5 m).

^ When vehicle pulling is due to conicity, the amount of drift can be reduced and the direction of drift can be changed by changing the location of the tire or reversing the tire when installing it on the wheel.

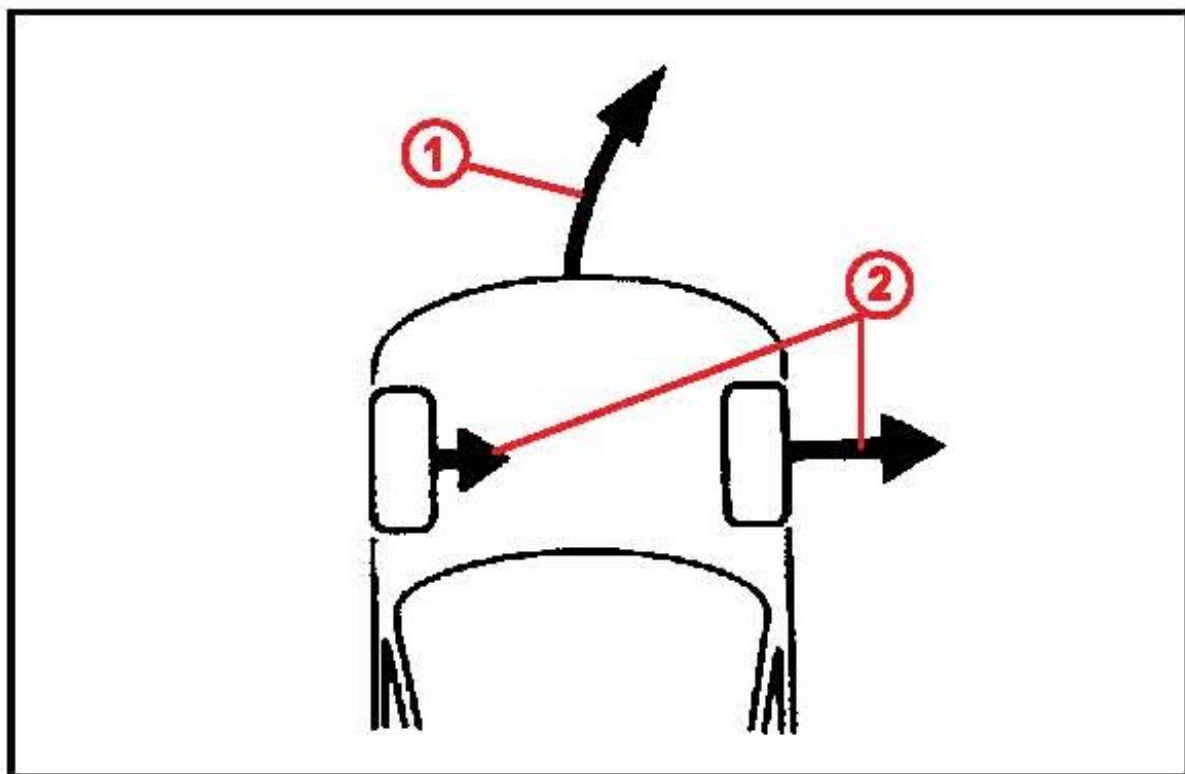
**Figure 6. Original Tire Positions**

^ The vehicle is pulled to the right by the lateral force exerted to the right.

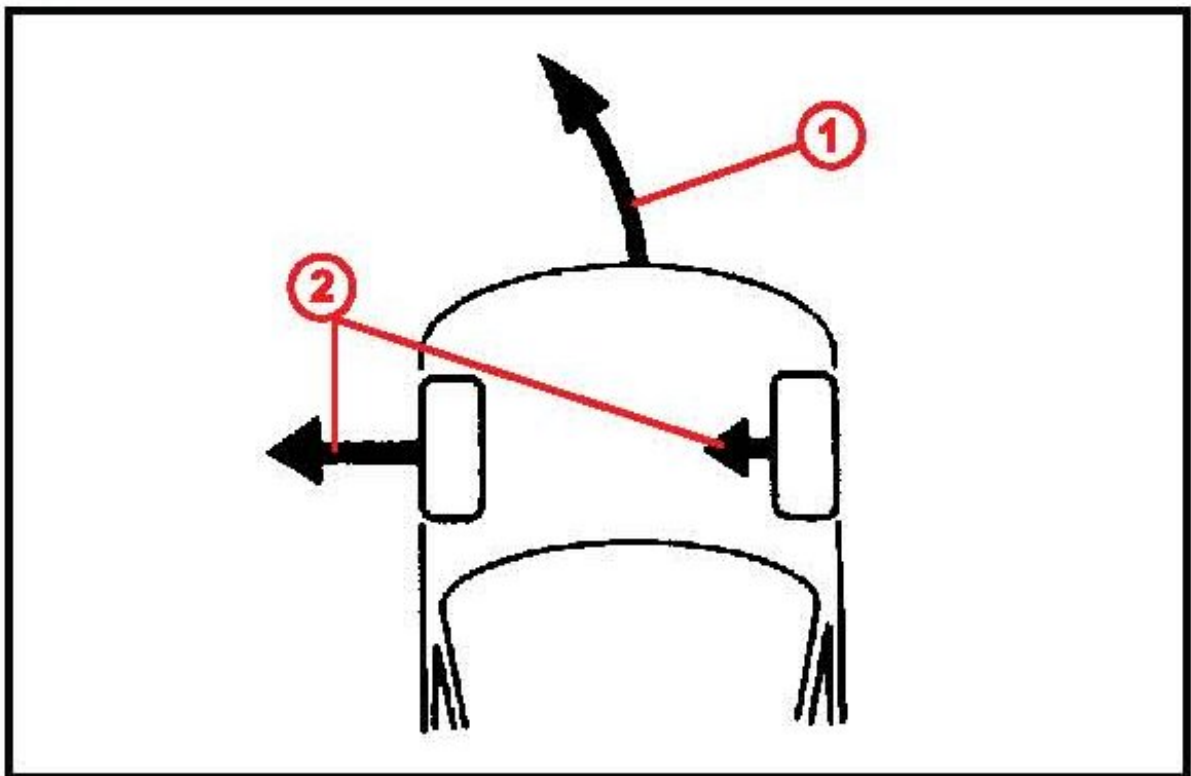
**Figure 7. Tires Switched**

^ The direction of the [tires](#) which exerted lateral force to the right has been changed, so the tires now exert lateral force to the left and the vehicle now pulls to the left.

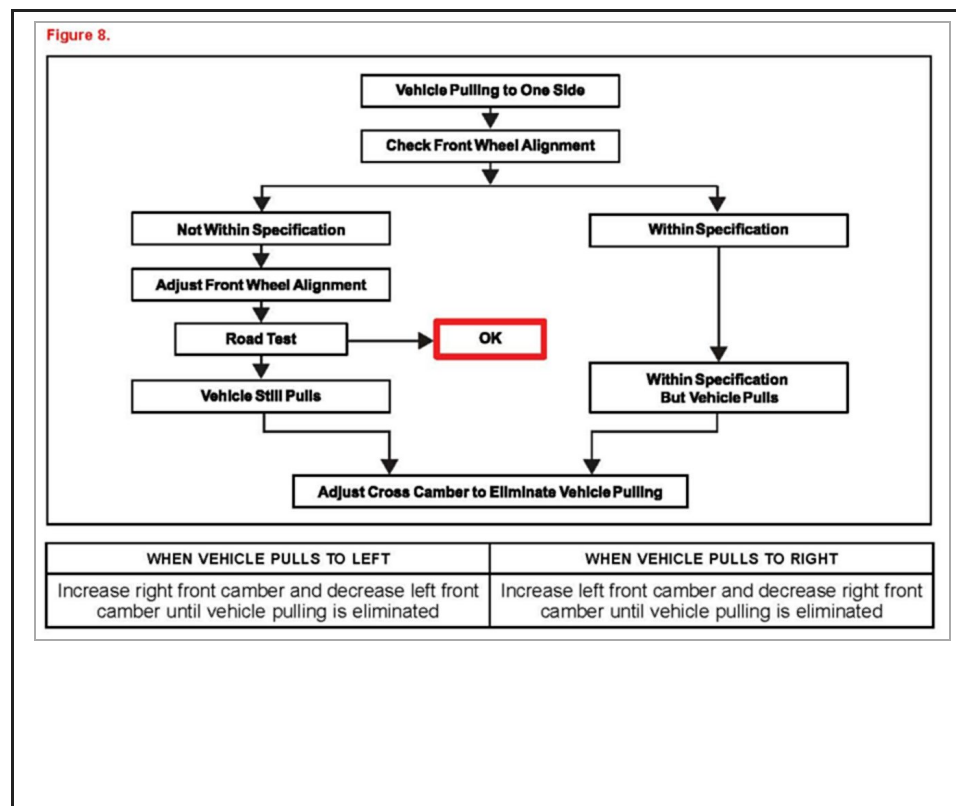
## 2. Vehicle Pulling Caused by Wheel Alignment.

When it is determined by troubleshooting that the vehicle pulling to one side is caused by wheel alignment perform repairs according to the following procedure.

^ Keep the cross camber within 10 or less.

^ Keep the camber of each wheel within specifications (+/-45' of center value).

^ If adjustment exceeds the specifications, uneven tire wear will result.

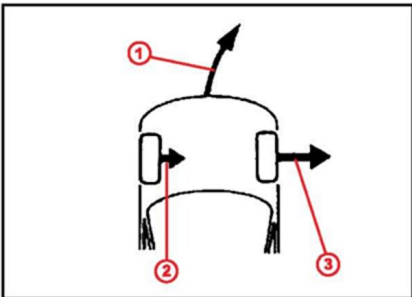
**Figure 9. Original Tire Positions**

The lateral force generated by the right front tire is greater than the left tire, so the vehicle is pulling due to the lateral force of the right tire.

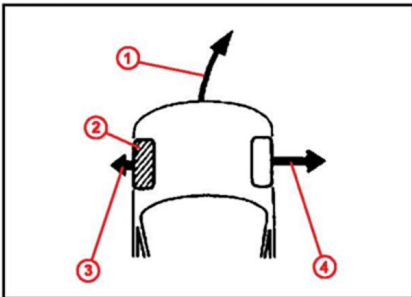
**Figure 10. Left Tire Reverse Installation**

**If Vehicle Pulls in the Same Direction: Go to step 3B.**

B. Rotate the larger lateral force front tire with the rear tire and check the change in the vehicle pulling.
