## Technical Service BULLETIN

# DRIVER'S DOOR POWER WINDOW AND MOON ROOF INITIALIZATION

'03 – '06 4Runner

PG018-02

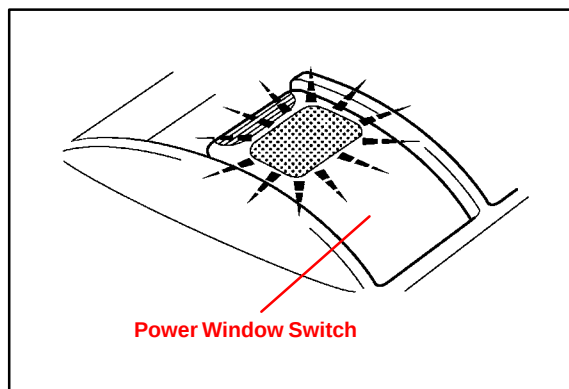
1. Push down and hold the driver's door power window switch to completely open the window.

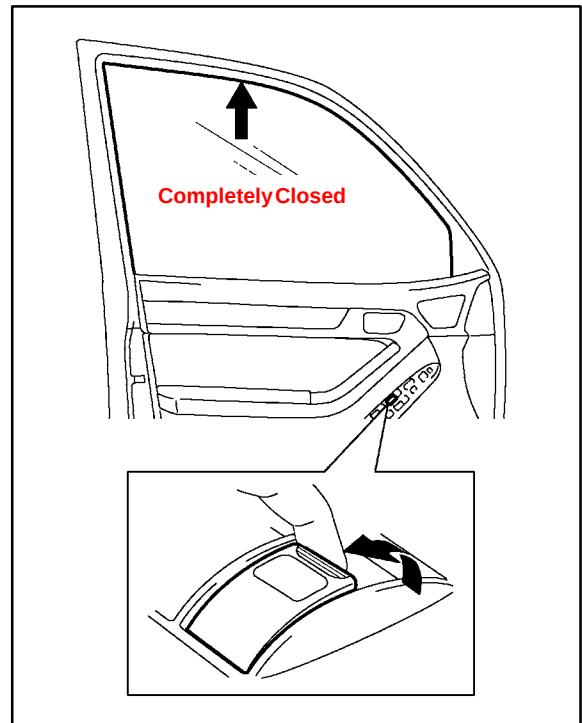
2. Pull and hold up the driver's door power window switch until the window closes. Continue holding the switch for approximately one second until the switch changes from blinking to a constant illumination.
3. Check for proper operation of the "one-touch open/close" by pushing the switch briefly to the "DOWN" and "UP" positions.

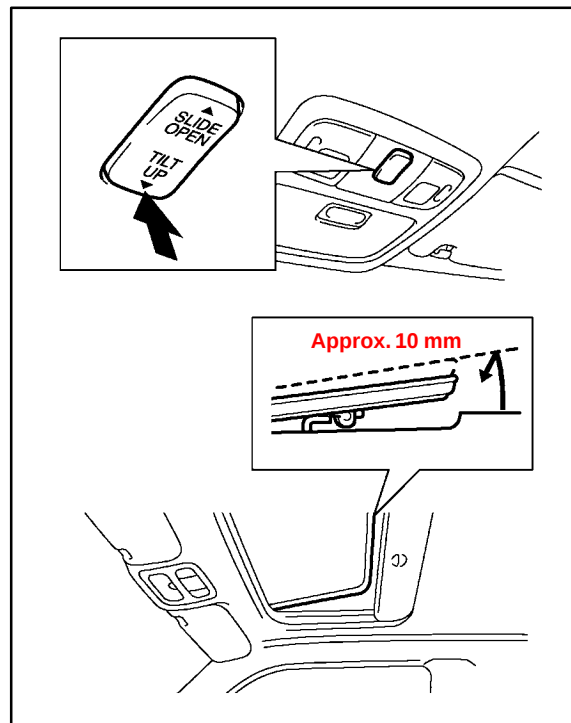
1. Push and hold the "TILT UP" side of the switch until the moon roof tilts all the way up and then tilts down slightly (approximately 10 mm [0.39 in.] at the rear).
2. Check for proper operation of the "one-touch slide open/close" and "one-touch tilt up/down" functions by pushing the switch briefly to the "SLIDE OPEN" and "TILT UP" positions.
