# Entune Audio Head Unit Software Update (Panasonic)

## Applicability

## Introduction

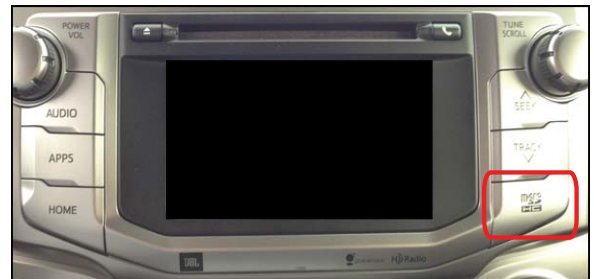
Figure 17.

If update fails and the error message *"New software is not compatible with the system."* displays, cycle the ignition OFF, remove the Map Micro SD Card from the head unit, and repeat steps 2 – 11.

Once update is complete, reinsert the Map Micro SD card into the head unit, cycle the ignition OFF, and proceed to step 13.
