# 1st to 2nd Gear Upshift Shudder

**Service Category** Drivetrain

**Section** Automatic Transmission/Transaxle

| YEAR(S) | MODEL(S) | ADDITIONAL INFORMATION |
|---|---|---|
| 2010 – 2012 | 4Runner | Drive Type(s): 4WD, 2WD<br>Engine(s): 1GR<br>Transmission(s): 5AT<br>VDS(s): BU5JR, ZU5JR |

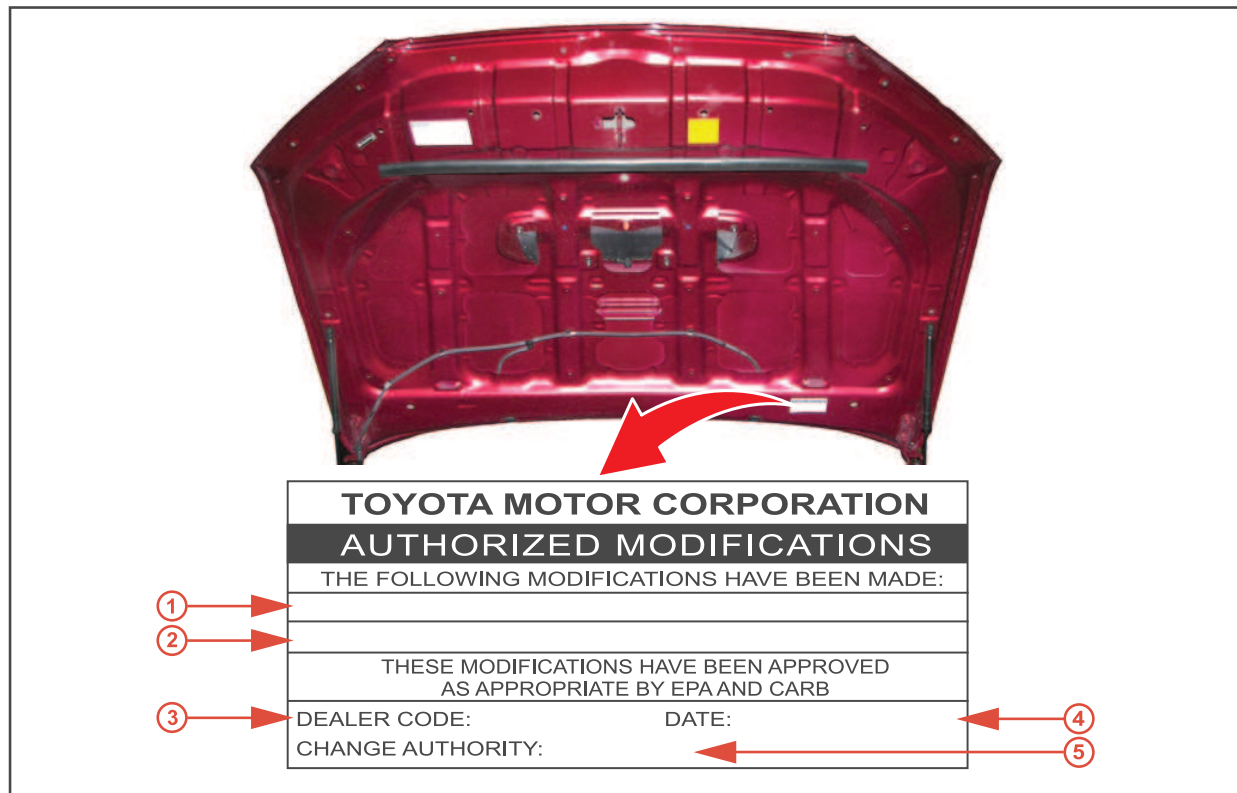
**Figure 1. Location of Authorized Modifications Label on 2010 – 2012 4Runner**

4. Check for the Authorized Modifications Label affixed to the vehicle in the location shown in Figure 1. Confirm if the ECM (PCM) calibration has been updated. If the calibration ID listed is NOT the latest ECM (PCM) calibration — go to step 5.

B. Affix the Authorized Modifications Label to the vehicle at the location shown in Figure 1.  
The Authorized Modifications Label is available through the MDC, P/N 00451-00001-LBL.
