## SEIZED/FROZEN CAM BOLT TOYOTA TRUCKS

### THE PROBLEM SOLVER®

##### Corrosion freezes the camber bolt in place

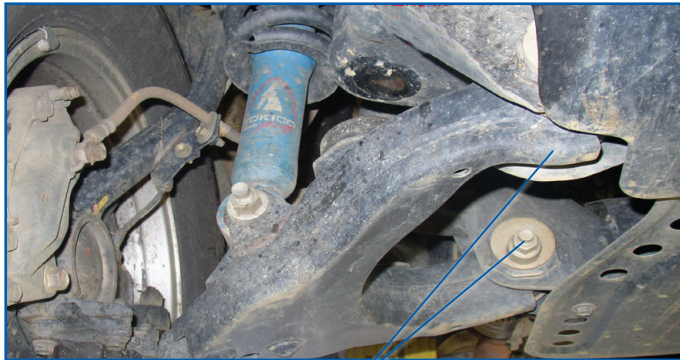
The camber adjustment bolt on lower control arms of certain Toyota trucks is subject to excessive corrosion (especially in the North, where salt is prevalent). The corrosion seizes the bolt and/or sleeve in the bushing, preventing rotation. The seized parts prevent the vehicle from being aligned properly. The process of removing the seized bolt can be difficult and may damage the bushing.

SEIZING OCCURS IN THESE  
AREAS, CAUSING ISSUES AND  
PREVENTING ALIGNMENT.
