**Technical Service BULLETIN**

**WINDSHIELD MOLDING DEFORMATION**

'03 – '04 4Runner

REVISED  
B0005-04  
BODY

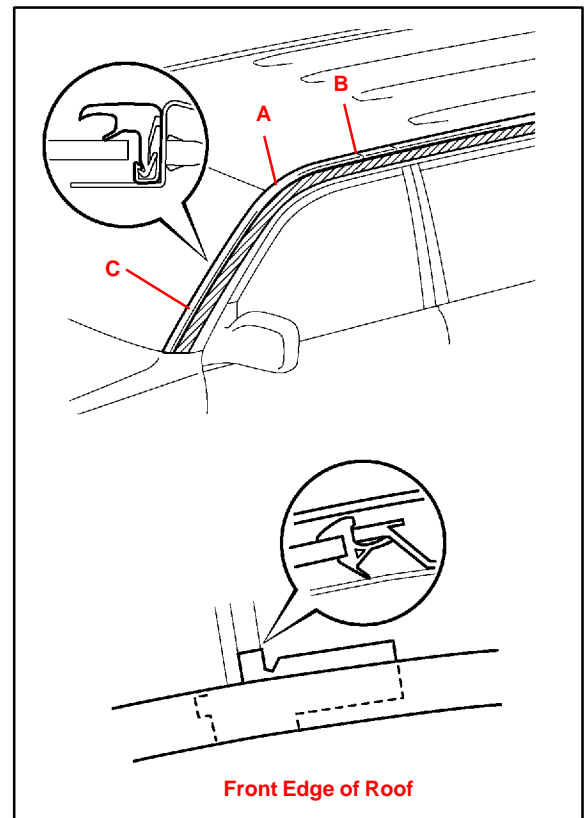
5. Install outside windshield molding No. 1.
  - A. Install the middle of the molding securely against the upper windshield molding as shown in the illustration.
  - B. Remove the backing from each of the 2 areas of adhesive tape and install the rear end of the molding to the roof.
  - C. Install the front end of the molding along the side of the windshield.
6. Reinstall the front fender to cowl side seal.
7. Reinstall the roof front drip side molding end cover.
