There is a rash of air mix servo motor failures in the 2001-2009 model Toyotas. In the last year, I've had bad ones on my 2003 4Runner, my wife's 2004 4Runner and yesterday my Dad's 2002 Avalon. Hopefully I can save you some time troubleshooting your vehicle and possibly allow you to fix it for free. I had my truck serviced under an extended warranty, and it took two service calls and over \$2000 of warranty work. On the other two vehicles, I fixed the problem for free in about an hour.

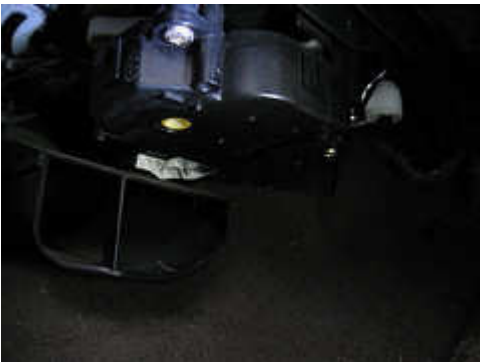
Replace - If you see these symptoms, there is a small chance that something else is damaged, but it's almost certain that your servo is bad. Note that dual temp A/C's have servos on drivers and passenger sides. The easy option is to buy a new servo for about \$100-\$130. However, I have successfully fixed two of them using a screwdriver and pair of small, long nosed, needle nose pliers.

Repair - Unscrew the servo unit from the car and disconnect the electrical cable. Gently pry the plastic clips with a flat screwdriver so you can separate the two halves of the case. Take note of the orientation of the motor and the white lever so you can replace them correctly. (With a marker, put a mark on the motor and the large gear so it's easy to identify their positions). Snap the motor out. Under the large plastic gear (which doesn't come out) you will see about 6 copper fingers that rub on the back of the gear. I believe the problem is that the fingers lose their spring and do not press hard enough against the resistive coating on the back of the gear. Take a small pair of long nose, needle nose pliers and grip all of the fingers near the base. Bend the fingers slightly upwards. Check that the white lever is in the same position as it was when you took the motor out. Reinstall the motor in the correct orientation making sure its electrical contacts fit between the copper fingers in the case. You can now put the cover back on. Note that if you break a clip, it's probably not a big deal since the mounting screws will hold the unit together.

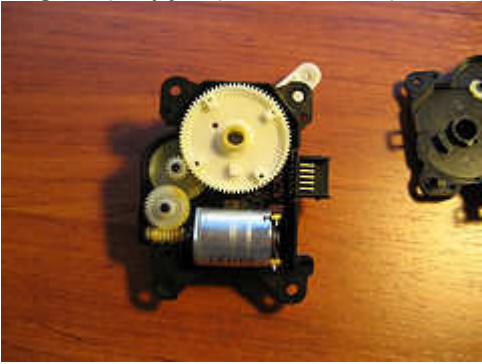
Testing - NOTE- watch your fingers! Without installing the unit on the car, plug the electrical cable into the servo. Run your AC or heater as above to move the lever from one extreme to the other and back into the middle region. If it no

longer rapidly jumps around, it's probably fixed.
