**TOYOTA**  
**Technical Service**  
**BULLETIN**  
 March 6, 2007

# DRIVESHAFT ASSEMBLY REPLACEMENT

'90 - '07 Toyota

TC003-07

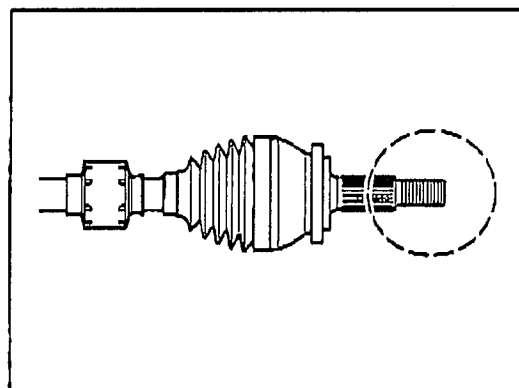
Clean the threaded area of the driveshaft with Toyota Brake Cleaner (or equivalent) to remove the anti-corrosion grease, oil, or foreign matter before installing the driveshaft into the vehicle.

A new axle hub nut may be required when installing the driveshaft. Check the Repair Manual procedure for more information.
