**TECHNICAL INSTRUCTIONS**

**SAFETY RECALL 90L**

**ACCELERATOR PEDAL MODIFICATION**

**2003 – Certain 2009 MODEL YEAR 4RUNNER**

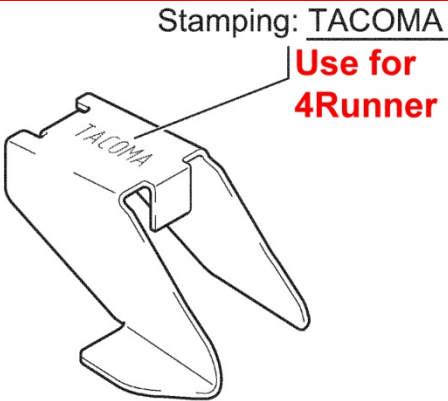
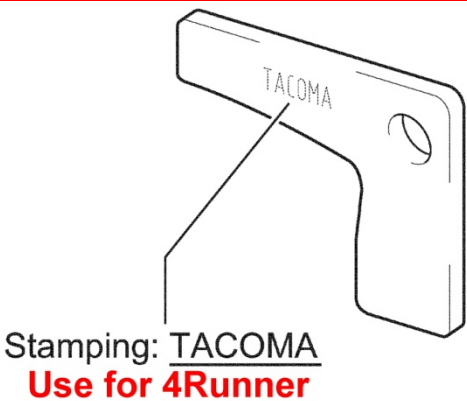
| The <b>Tacoma</b> Template and Shape Gauge will be used to modify the <b>4Runner</b> accelerator pedal | |
| Cutting Template (Color: <b>RED</b> ) | Shape Gauge (Color: <b>RED</b> ) |
