TO: ALL TOYOTA DEALER PRINCIPALS,
SERVICE MANAGERS, PARTS MANAGERS

SUBJECT: SPECIAL SERVICE CAMPAIGN (SSC) – 50J PHASE 1
(FRONT SUSPENSION LOWER BALL JOINT)

**FRONT SUSPENSION LOWER BALL JOINT REPLACEMENT
FOR THE FOLLOWING VEHICLES**

(Updated on January 18, 2007)

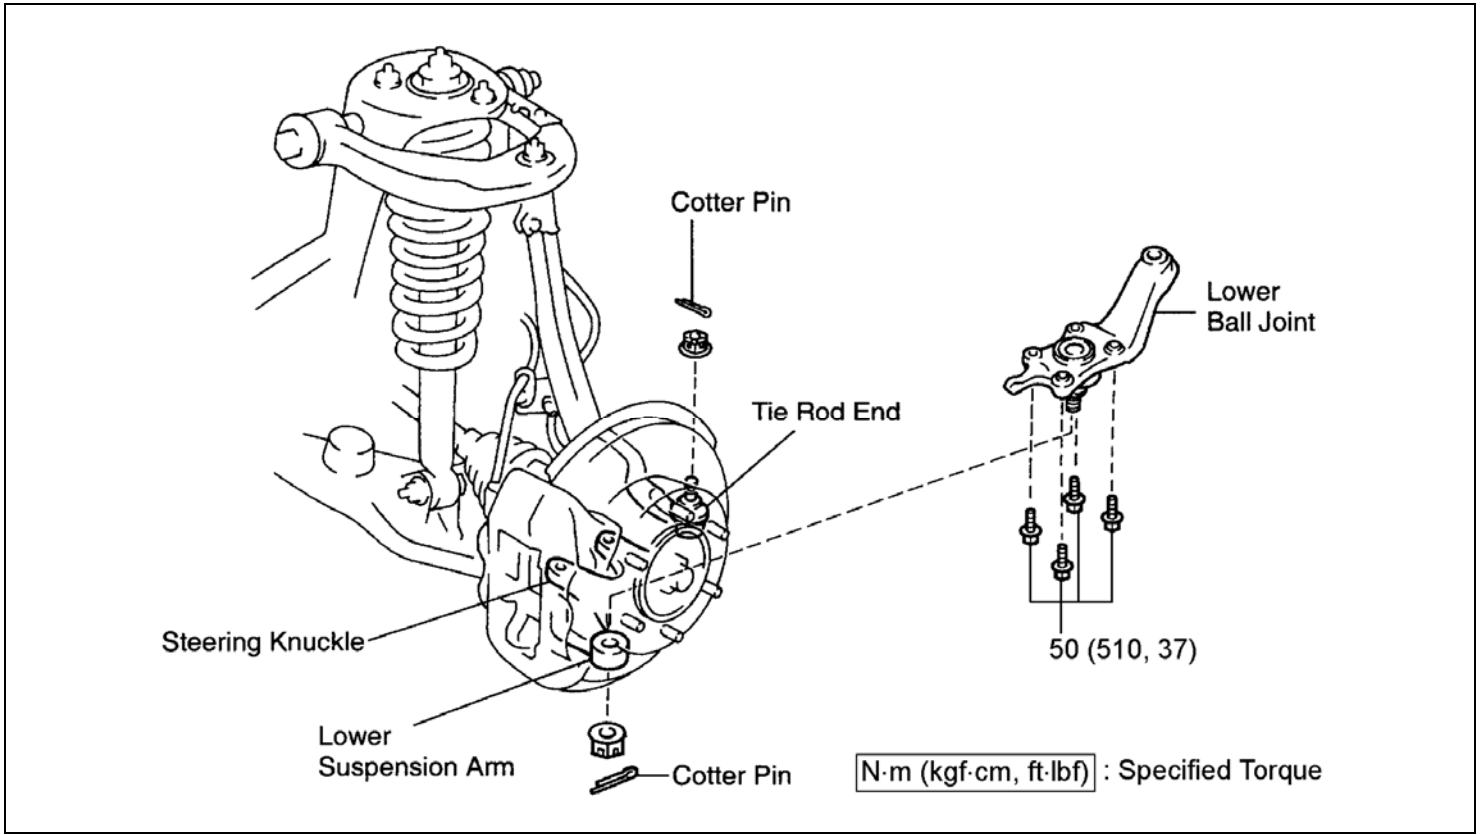
A. 4Runner

On certain 2001 – 2002 Model Year 4Runner, 2001 – mid-2004 Model Year Tacoma 4WD and PreRunner, and 2002 – early 2004 Model Year Sequoia and Tundra vehicles, there is a possibility that the Front Suspension Lower Ball Joint may experience excessive wear and looseness causing increased steering effort, reduced vehicle self-centering, and noise in the front suspension.
