## Repair Manual Supplement: Vehicle Pulling to One Side

Alignment/Handling Diagnoses

**TSB SUPERSESSION NOTICE**

This bulletin contains general vehicle pulling diagnosis and repair procedures along with specific information to help correct pulling complaints.

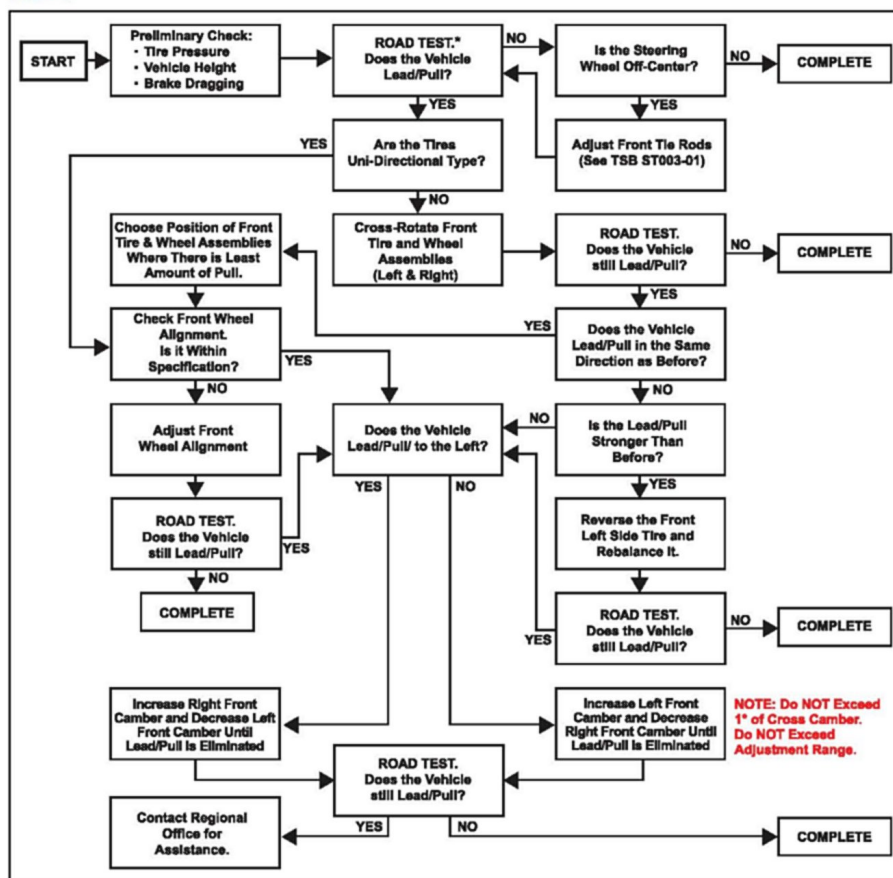
Figure 5.

^ In the case of vehicle pulling caused by [tires](#), the lateral force which is exerted as a result of conicity has the greatest effect. On a flat road, if the steering wheel is held without exerting steering effort for 109 yards (100 m) when traveling at 62 mph (100 km/h), the vehicle may drift as much as 5 feet (1.5 m).

^ When vehicle pulling is due to conicity, the amount of drift can be reduced and the direction of drift can be changed by changing the location of the tire or reversing the tire when installing it on the wheel.
