# Entune Audio Head Unit Software Update (Panasonic)

**Service Category** Audio/Visual/Telematics

**Section** Navigation/Multi Info Display

## Introduction

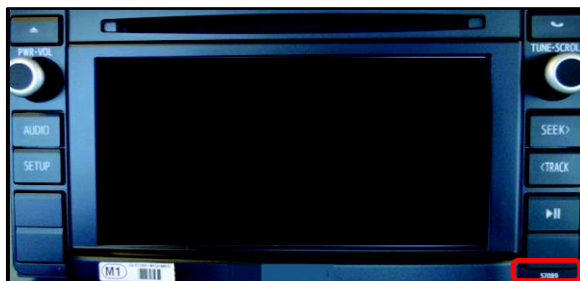
**Figure 1. Avalon, Avalon HV, Highlander, Highlander HV, Prius, Prius V, Sienna, Sequoia, Tacoma, and Tundra**

1. Confirm the audio system type by checking the faceplate ID printed on the bottom-right or bottom-center of the head unit. See Table 1 for the applicable model faceplate ID number.

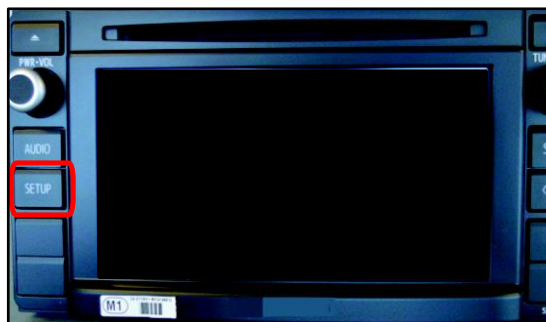
**Figure 3. Tacoma, Prius, Prius V**

2. Start the engine.
3. Insert the USB flash drive with the downloaded multimedia update file into the vehicle's USB port.
4. Go to the Setup screen.
  - A. For Entune™ Audio: Press the Setup button on the panel.

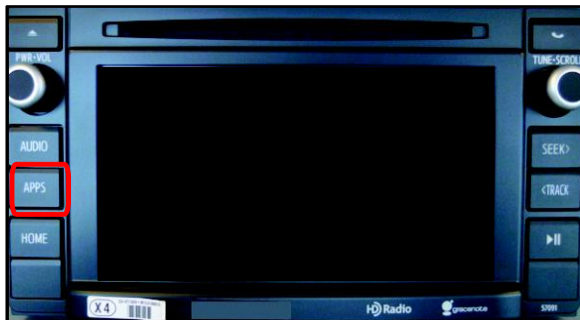
**Figure 5. 4Runner, Avalon, Avalon HV, Highlander, Highlander HV, Prius, Prius V, Sienna, Sequoia, and Tacoma**

- B. For Entune™ Audio Plus and Entune™ Premium Audio: Press the Apps button on the panel.

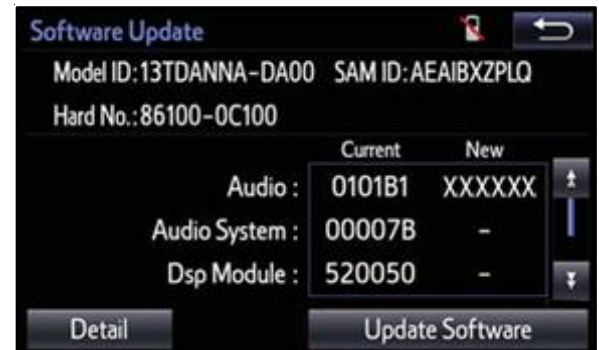
Figure 13.

9. Verify that the NEW software is up to date on the Software Update screen.

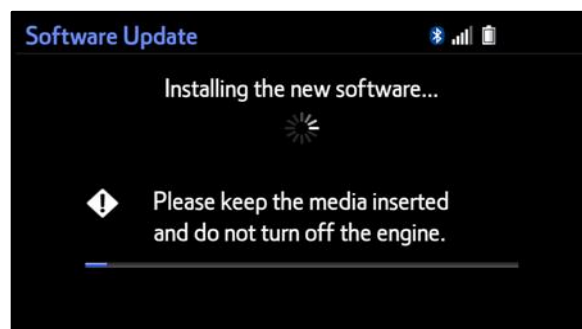
Figure 16.

- If the update fails and the error message “New software is not compatible with the system” displays, cycle the ignition OFF, remove the map micro SD card from the head unit, then repeat steps 3 – 12.
- A software update error is more likely to occur in areas with more traffic information.

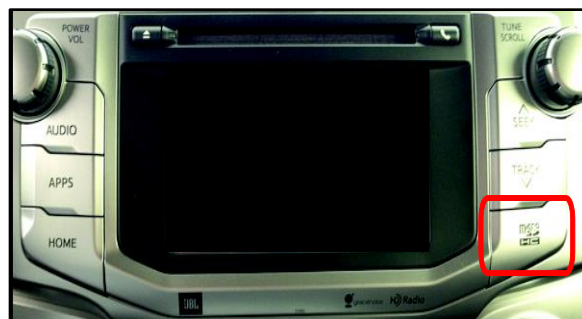
Figure 17.

Once the update is completed, reinsert the map micro SD card into the head unit, cycle the ignition OFF, then continue to step 13.

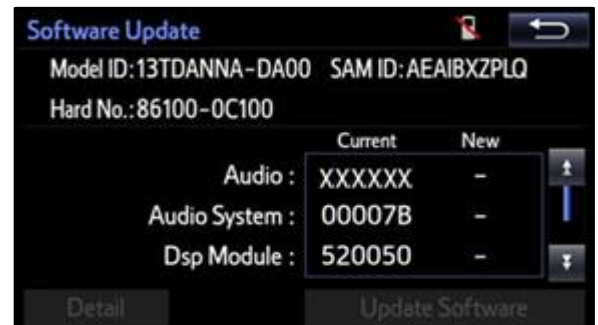
**Figure 19.**

1. Perform steps 3 – 7 of the Software Update Procedure to re-enter the Software Update screen.
2. Verify that the software information is updated on the Software Update screen. See Table 3 for the current software version.
