| <b>Model Year:</b> 2010 | <b>Model:</b> 4Runner | <b>Doc ID:</b> RM00000460B000X |
| <b>Title:</b> INTERIOR PANELS / TRIM: FRONT CONSOLE BOX (for 1GR-FE): REMOVAL (2010 4Runner) | | |

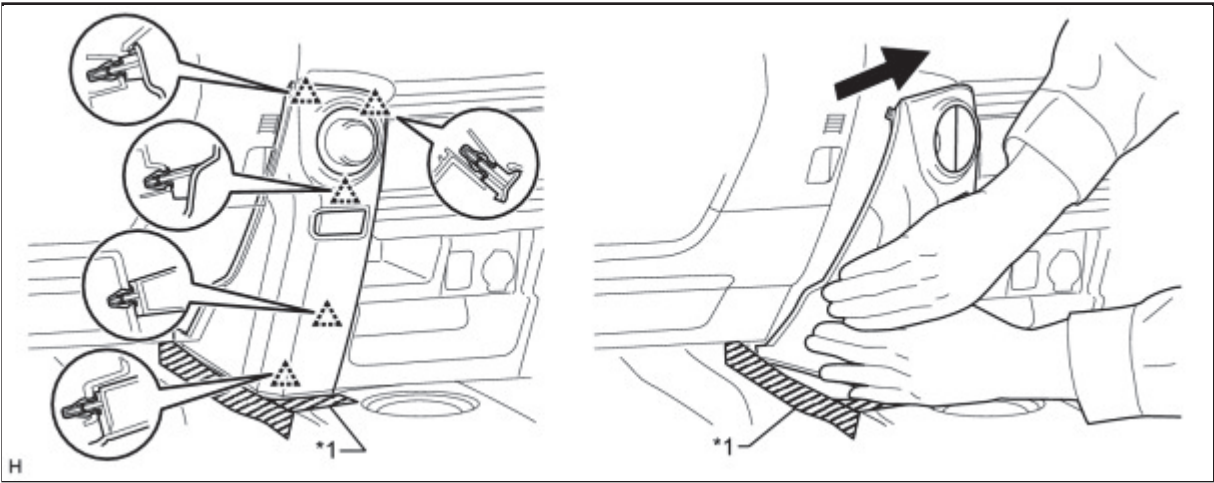
1. REMOVE NO. 1 INSTRUMENT CLUSTER FINISH PANEL GARNISH

- (a) Open the instrument cluster finish panel lid.
- (b) Put protective tape around the No. 1 instrument cluster finish panel garnish.
- (c) Grip the No. 1 instrument cluster finish panel garnish and pull it diagonally upward toward the rear to detach the 5 clips and remove the No. 1 instrument cluster finish panel garnish.

| *1 | Protective Tape | - | - |

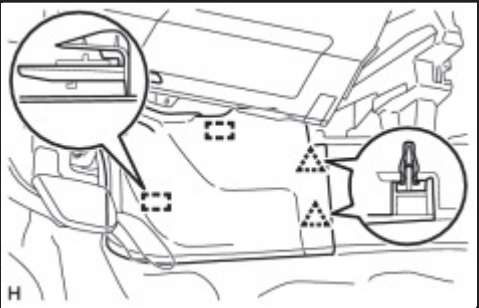
3. REMOVE FRONT NO. 1 CONSOLE BOX INSERT

- (a) Detach the 2 clips and 2 guides and remove the front No. 1 console box insert.

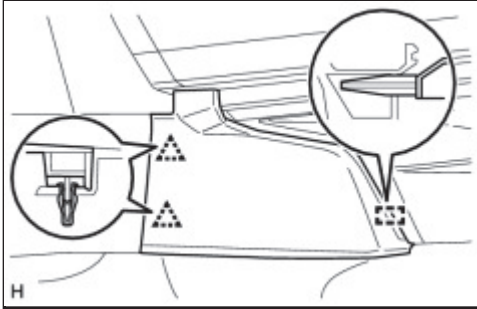
#### 4. REMOVE FRONT NO. 2 CONSOLE BOX INSERT

- (a) Detach the 2 clips and guide and remove the front No. 2 console box insert.

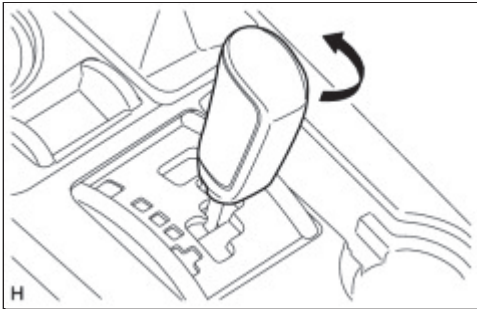
#### 5. REMOVE SHIFT LEVER KNOB SUB-ASSEMBLY

- (a) Twist the shift lever knob in the direction indicated by the arrow and remove it.

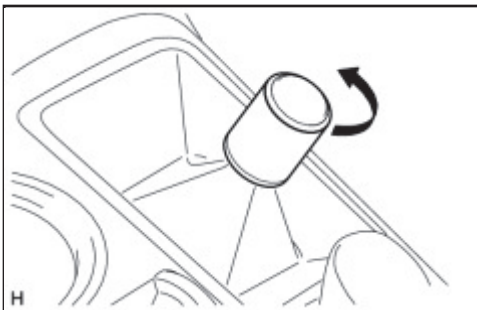
#### 6. REMOVE SHIFT LEVER KNOB SUB-ASSEMBLY (for VF2A)

- (a) Twist the shift lever knob in the direction indicated by the arrow and remove it.

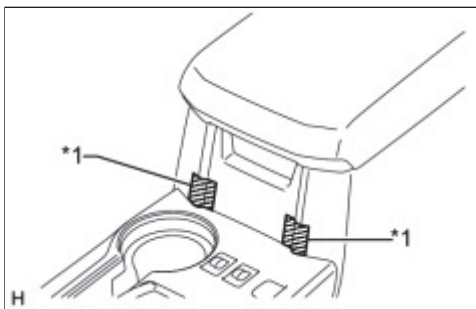
#### 7. REMOVE UPPER CONSOLE PANEL SUB-ASSEMBLY

- (a) Put protective tape around the upper console panel.

| * 1 | Protective Tape |

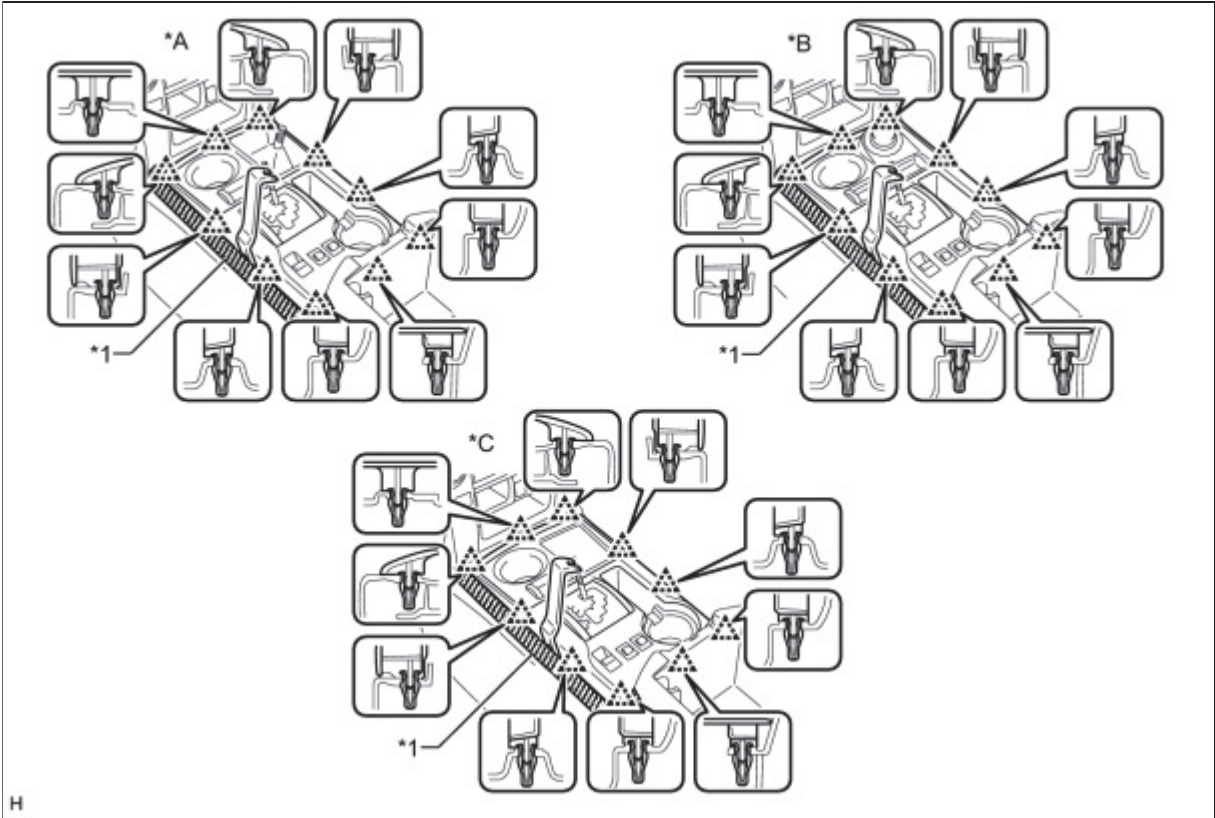
- (b) Using a moulding remover, detach the 10 clips.
- (c) Disconnect each connector and remove the upper console panel.

| * A | for VF2A | * B | for VF4BM |
| * C | for 2WD | - | - |
| * 1 | Protective Tape | - | - |

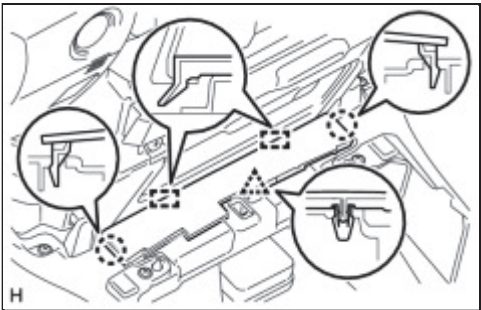
8. REMOVE NO. 2 CONSOLE BOX RETAINER

- (a) Detach the clips, 2 claws and 2 guides and remove the No. 2 console box retainer.

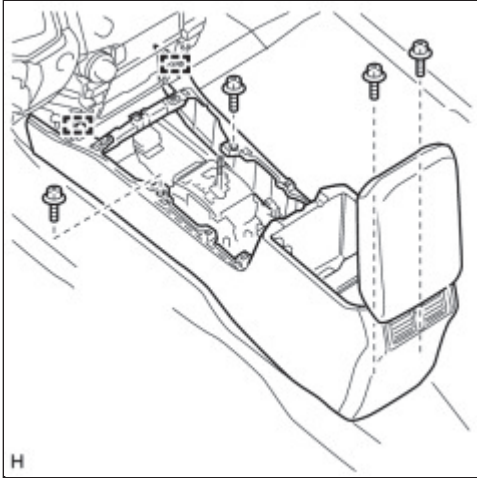
## 9. REMOVE REAR CONSOLE BOX ASSEMBLY

- (a) Remove the 4 bolts.
- (b) Detach the 2 guides.
- (c) Disconnect each connector and remove the rear console box.
