## Steering Column 'Clack' resolved

2003 Sport Edition, V6 , Tilt / Telescope steering wheel.

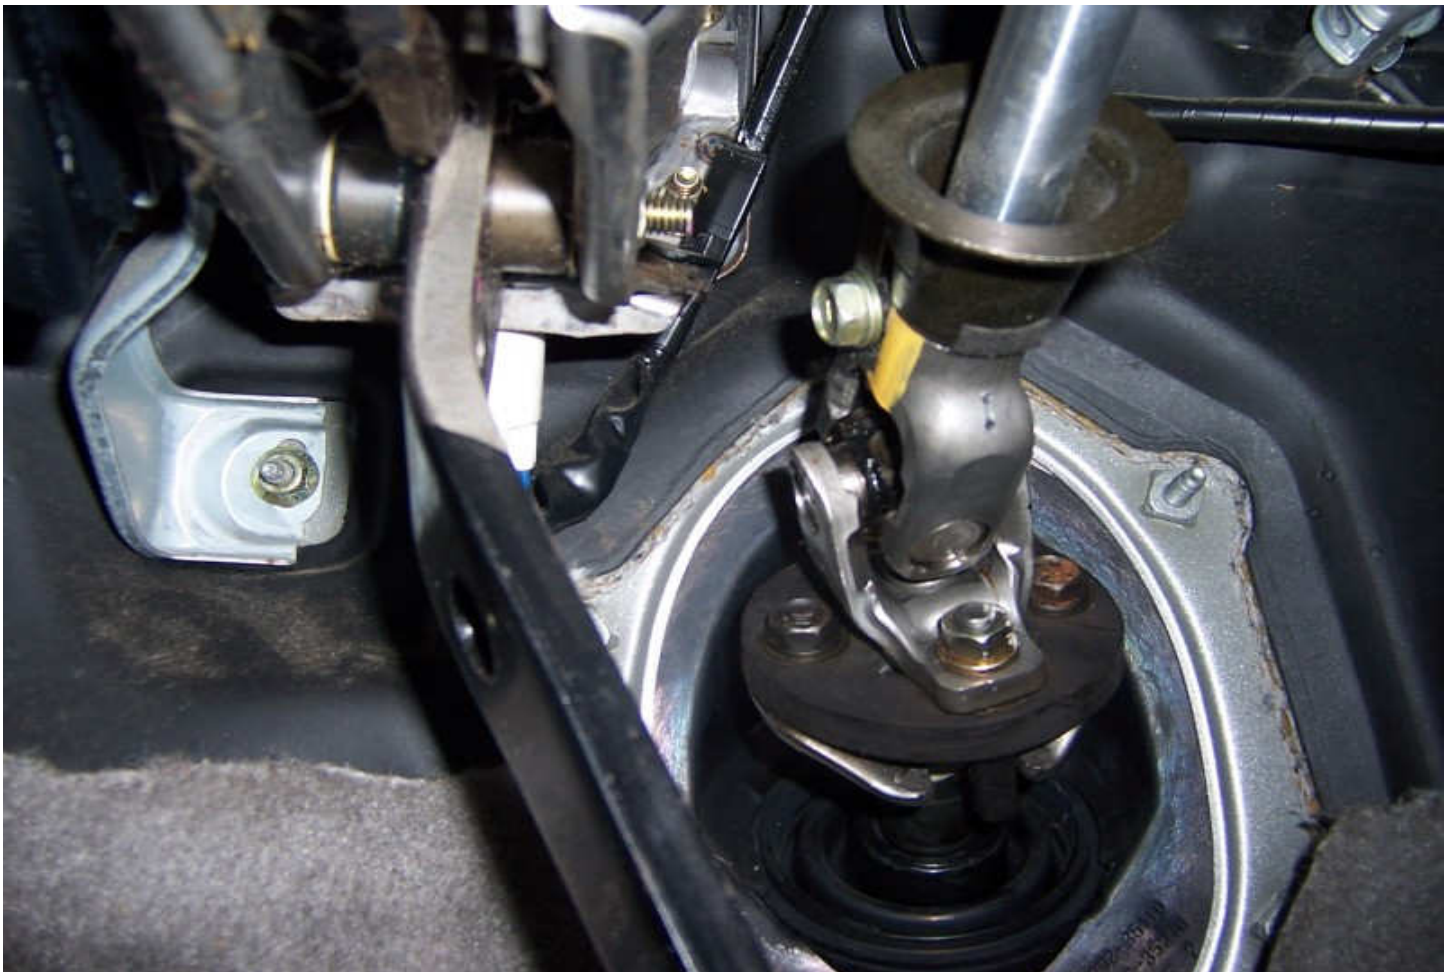
The Gold bolt next to the yellow paint. You can turn the steering wheel to get bolt head in a good position.

Resolution: Behind the break pedal at the firewall remove 4 plastic nuts holding on a cone shaped cover around steering shaft and remove it. Note where the steering shaft connects to the u joint assembly there is a ...funnel...shaped collar around the shaft, it is held in place by one 12mm bolt which also is the bolt which compresses the joint around the splined shaft.

Tighten the 12mm bolt.
